## Factual Update

October 16, 2019

# Fire and Explosions at Philadelphia Energy Solutions Refinery Hydrofluoric Acid Alkylation Unit

Philadelphia, Pennsylvania | Incident Date: June 21, 2019 | No. 2019-06-I-PA

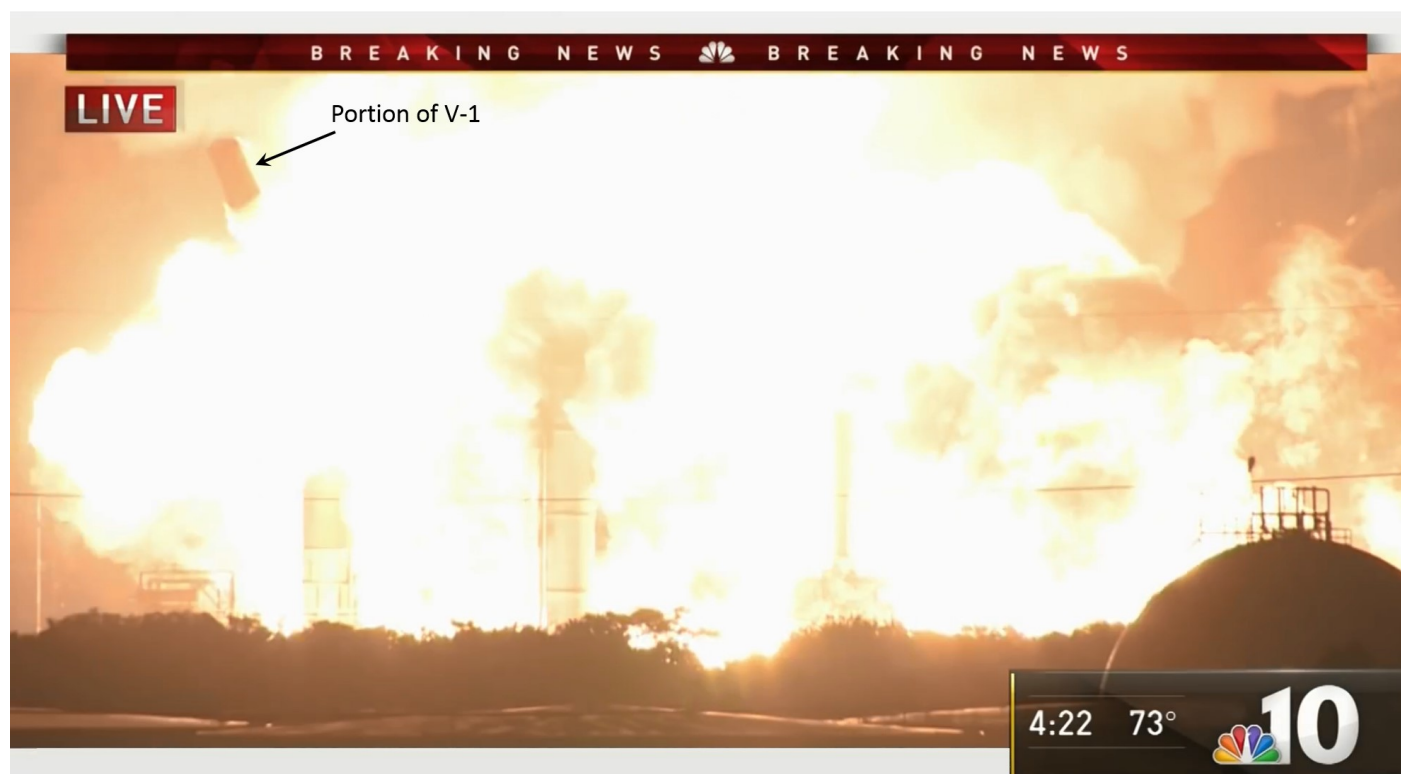
- At 4:15 am, during the ongoing fire, an explosion occurred in the alkylation unit. A second explosion in the unit then occurred at 4:19 am.
- At 4:22 am, a third, and the largest, explosion occurred when the V-1 Treater Feed Surge Drum, containing primarily butylene, isobutane, and butane, violently ruptured (Figure 4, Figure 5). A fragment of the vessel weighing approximately 38,000 pounds flew across the Schuylkill River, and two other fragments, one weighing about 23,000 pounds and the other 15,500 pounds, landed in the PES refinery (Figure 6). This appears to be a secondary event caused by the fire.

Figure 4. Video still of V-1 explosion. (Credit: NBC10 Philadelphia<sup>a</sup>).

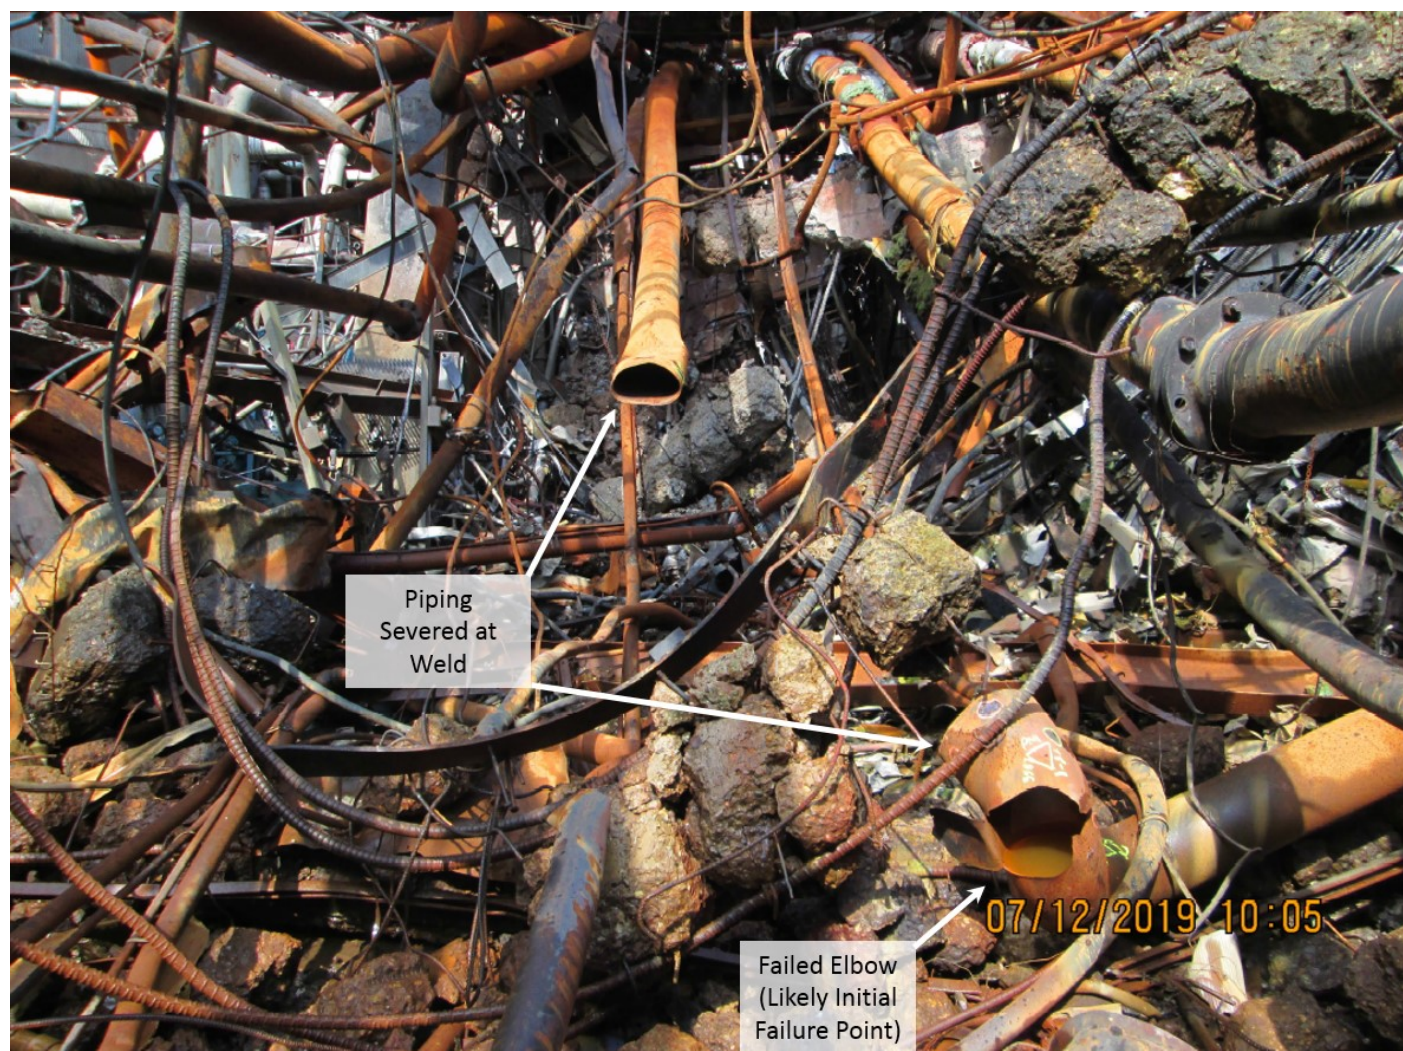
- A ruptured pipe elbow was found in the unit post-incident (Figure 7). The rupture of the elbow appears to be the initiating event causing the process fluid release. The elbow was part of the piping between V-11, the depropanizer accumulator, and T-6, the depropanizer distillation column. The elbow was on the discharge (outlet) piping from a pump (one of two pumps in this system) that was not operating at the time of the incident. At the time of the event, this piping was operating at a pressure of about 380 psig and a temperature of about 100 °F. The approximate design composition of process fluid in the piping was:

Figure 7. Photo of ruptured pipe elbow found post-incident. (Credit: PES).

- A CML was not located on the ruptured elbow, so the thickness of this elbow was not monitored. The thinnest measurement taken of the ruptured elbow post-incident was 0.012 inch.<sup>b,c</sup> This value is less than 7 % of the PES default retirement thickness.

- The piping circuit containing the ruptured elbow was installed in about 1973. As of this Factual Update, this piping appears to be the original piping. Both the elbow that failed and the adjacent elbow are stamped “WPB”, indicating they were constructed to meet the ASTM A234 WPB material specifications.

- The 1965 version of ASTM A234 *Standard Specification for Factory-Made Wrought Carbon Steel and Ferritic Alloy Steel Welding Fittings*, the applicable version at the time of the pipe installation, required that Grade WPB pipe “permissible raw materials” composition meet the A106 Grade B chemical composition specifications. The 1972 ASTM A106 standard did not specify nickel (Ni) and copper (Cu) composition requirements. In 1995, ASTM A234 began specifying nickel and copper composition, as well as compositions of other elements.<sup>a</sup> The WPB composition requirements in 1972 and 1995<sup>b</sup> are shown below. The chemical composition of the ruptured elbow and the adjacent elbow are also shown. The nickel and copper content of the ruptured elbow exceeds the updated A234 WPB chemical composition requirements.

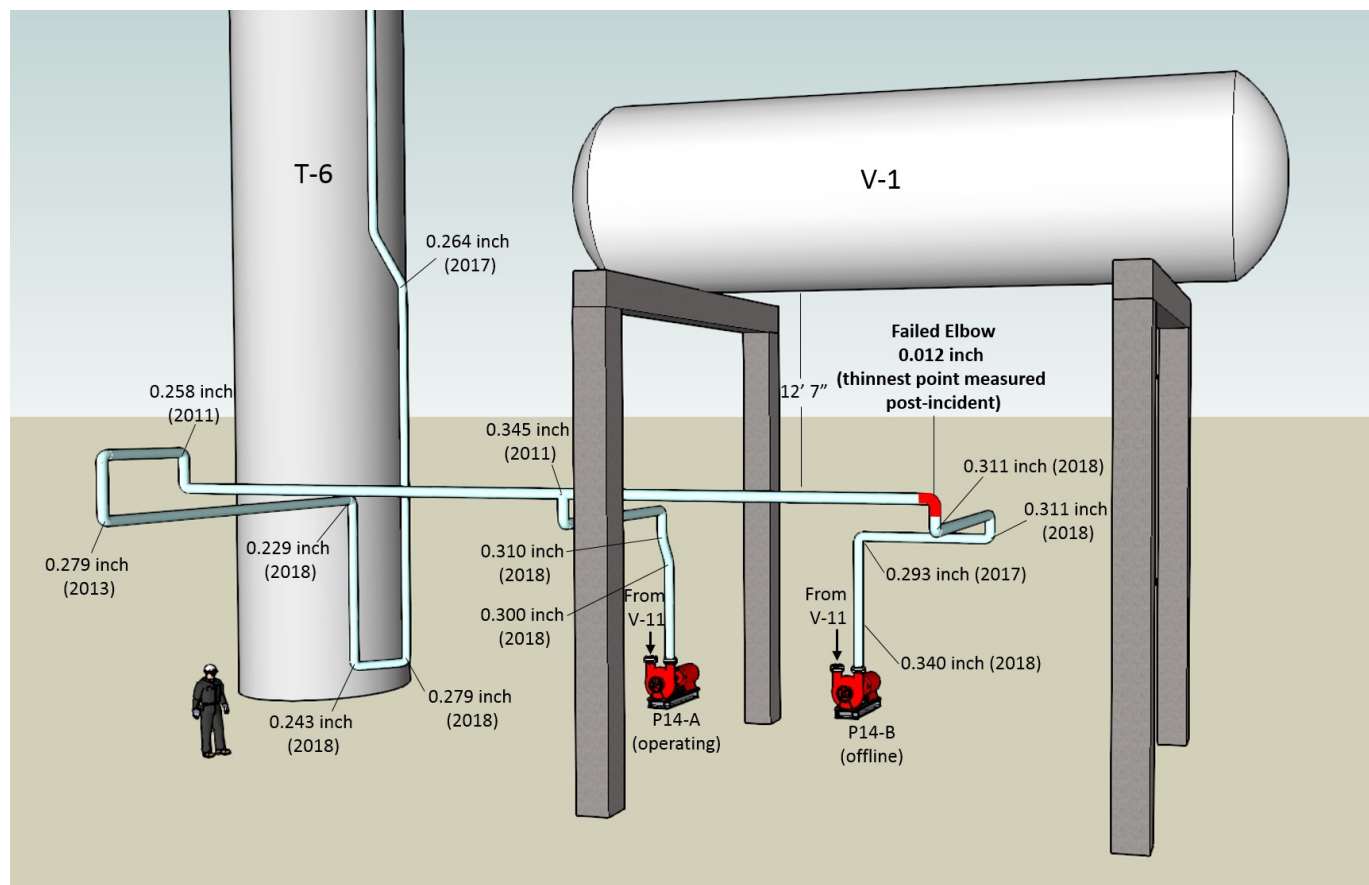
- The piping circuit that includes the ruptured elbow was subject to regular ultrasonic thickness measurements at designated condition monitoring locations (CMLs),<sup>a</sup> as part of the PES inspection program to monitor the rate of piping metal loss due to corrosion. Locations of CMLs and the most recent thickness measurements are

shown in Figure 8. The default retirement thickness<sup>a</sup> of this piping in the PES inspection database is 0.180-inch. The most recent CML measurements did not indicate thin pipe.

Figure 8. Model of the piping circuit containing the ruptured elbow. The most recent thickness measurements at designated Condition Monitoring Locations (CMLs) are shown. The year of each measurement is shown in parentheses. This figure also illustrates that V-1 was directly above the ruptured elbow. (Credit: CSB).
