## Factual Update

October 16, 2019

# Fire and Explosions at Philadelphia Energy Solutions Refinery Hydrofluoric Acid Alkylation Unit

Philadelphia, Pennsylvania | Incident Date: June 21, 2019 | No. 2019-06-I-PA

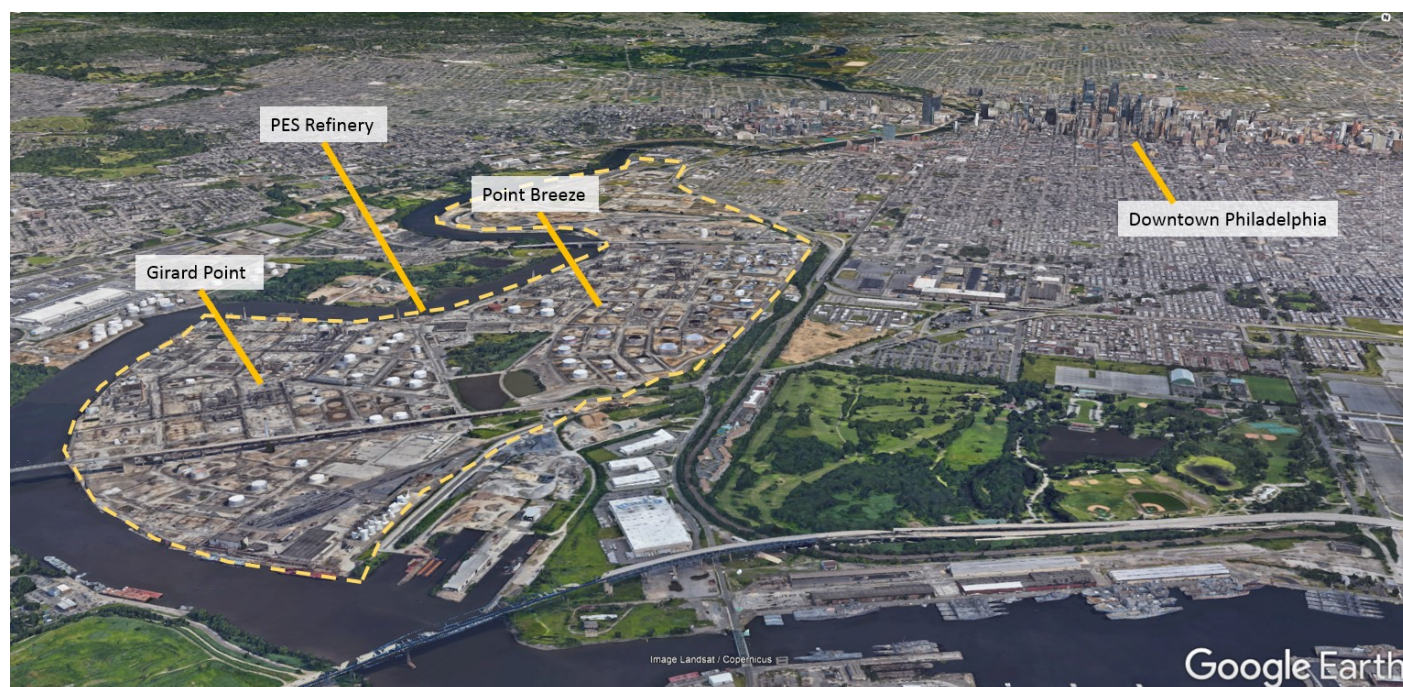
Figure 1. Overhead view of the PES Refinery in Philadelphia, Pennsylvania, showing the Girard Point and Point Breeze refineries. (Credit: Google Earth with modifications by CSB).
